Hearing Statement

Matter 6(ii): Other Allocations for Housing and Mixed Uses; Reserved Housing Sites - Stourport on Severn

**CONDITION SURVEY ASSESSMENT INCLUDING ALL
WEATHER PITCH BUDGET FEASIBILITY REVIEW**

STOURPORT HIGH SCHOOL AND SIXTH FORM CENTRE - BUDGET REPAIRS COSTS OCT 2020

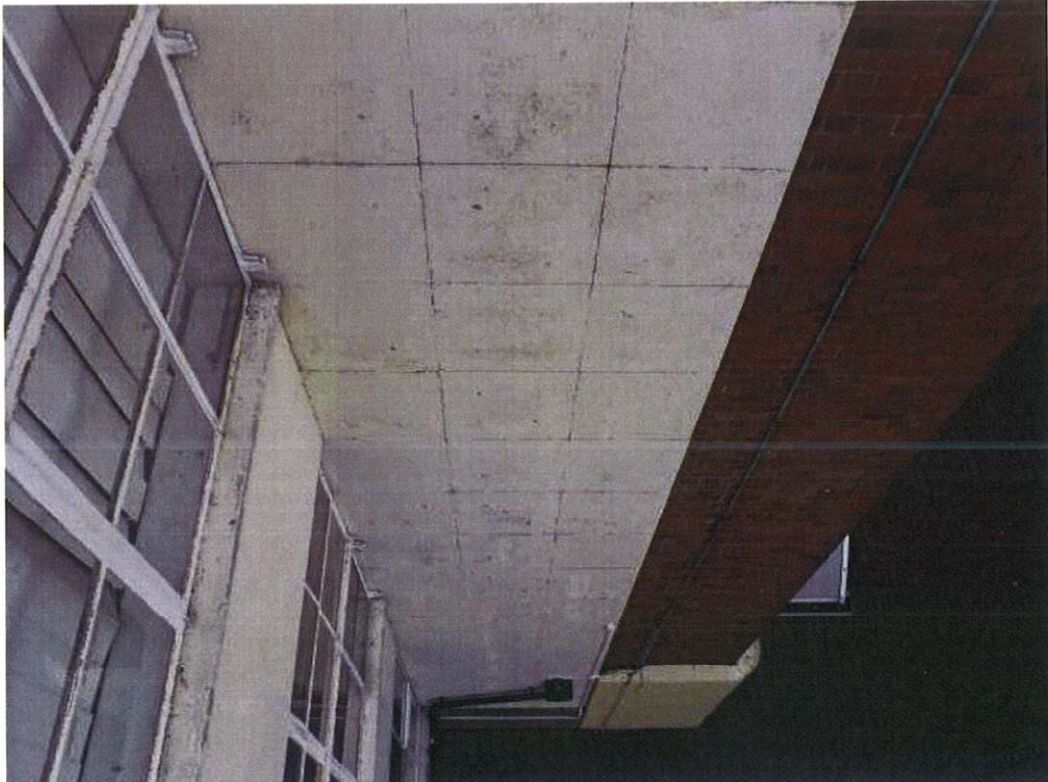
Photo 13: General view showing front elevation C.

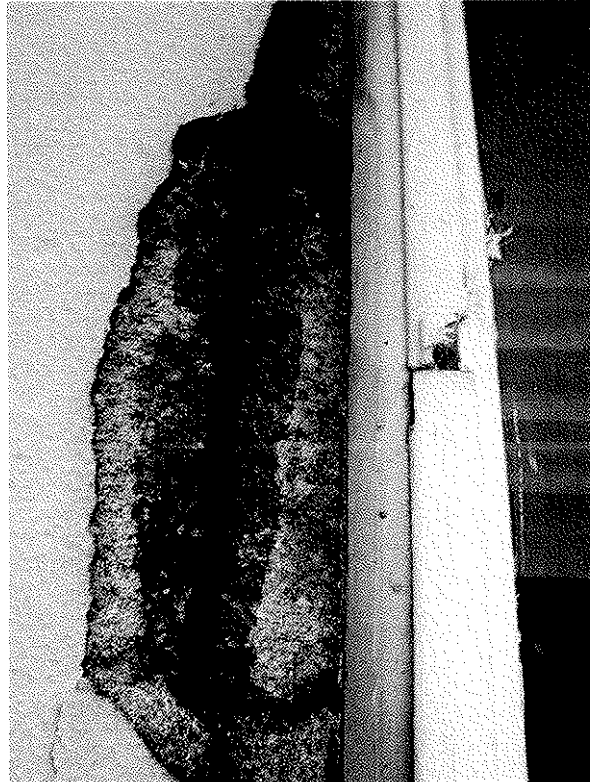
Photo 15: Detailed view showing an area of spalling with exposed reinforcement measuring 150x440x40 at the internal side elevation.

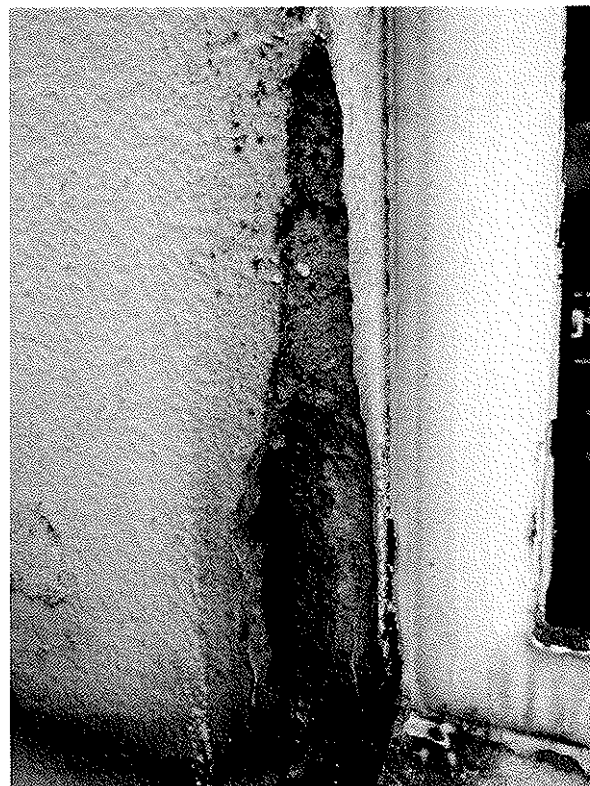
Photo 16: Detailed view showing an area of spalling with exposed reinforcement measuring 250x200x4mm at the internal side elevation.

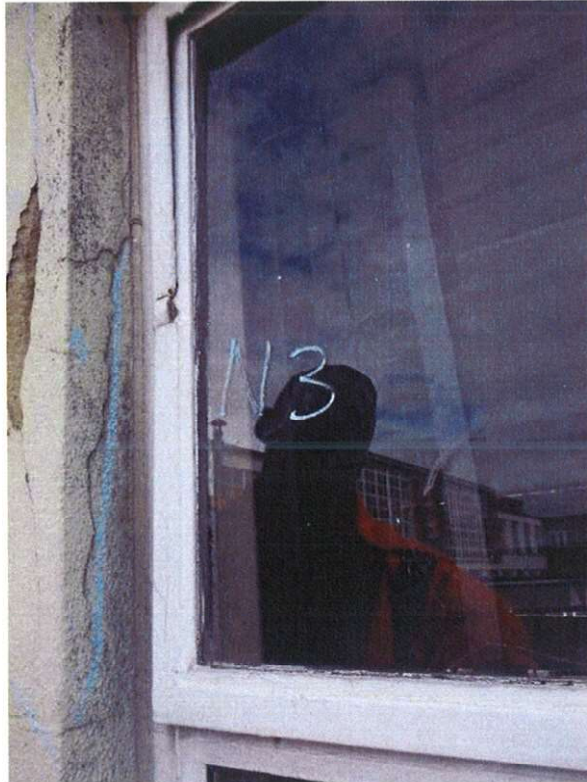
Photo 17: Detailed view showing an area of spalling with exposed reinforcement measuring 45x550x25mm at the internal side elevation.

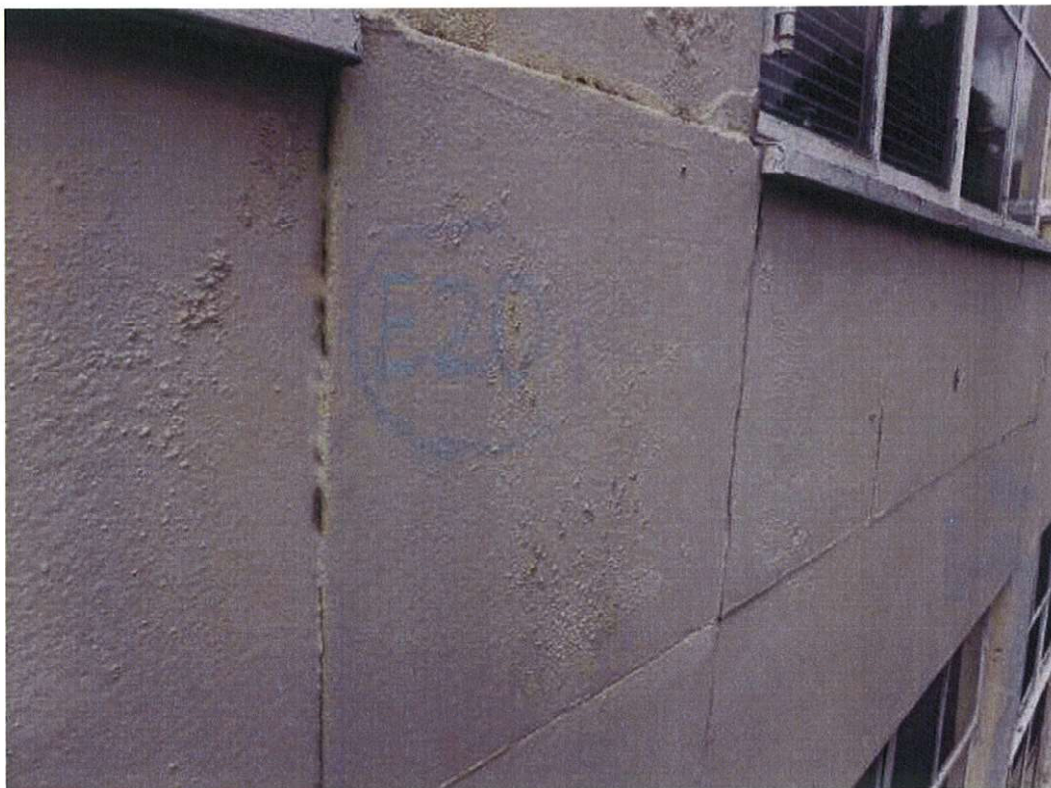
Photo 18: View showing a misaligned panel by up to 8mm on the front elevation, towards the south.

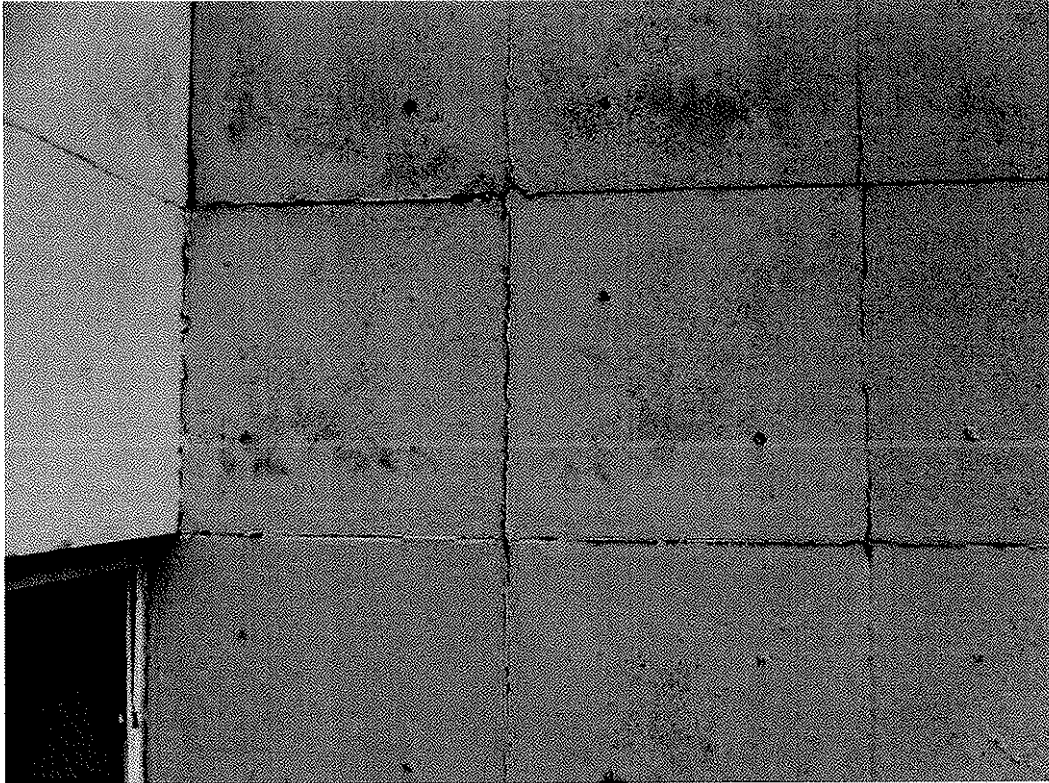
Photo 19: General view showing cracks to the paint at the panel joints typical throughout the structure.

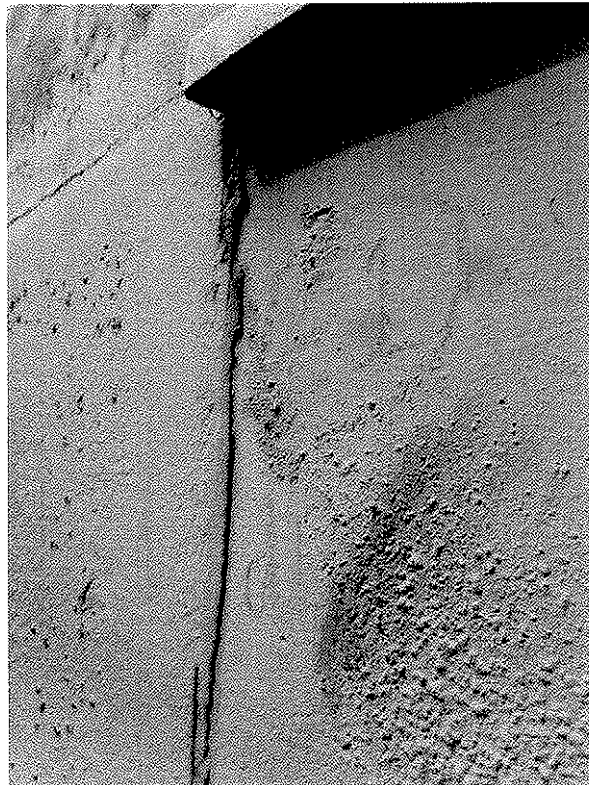
Photo 20: View showing a misaligned panel by 5mm to the front elevation which were typical throughout the structure.

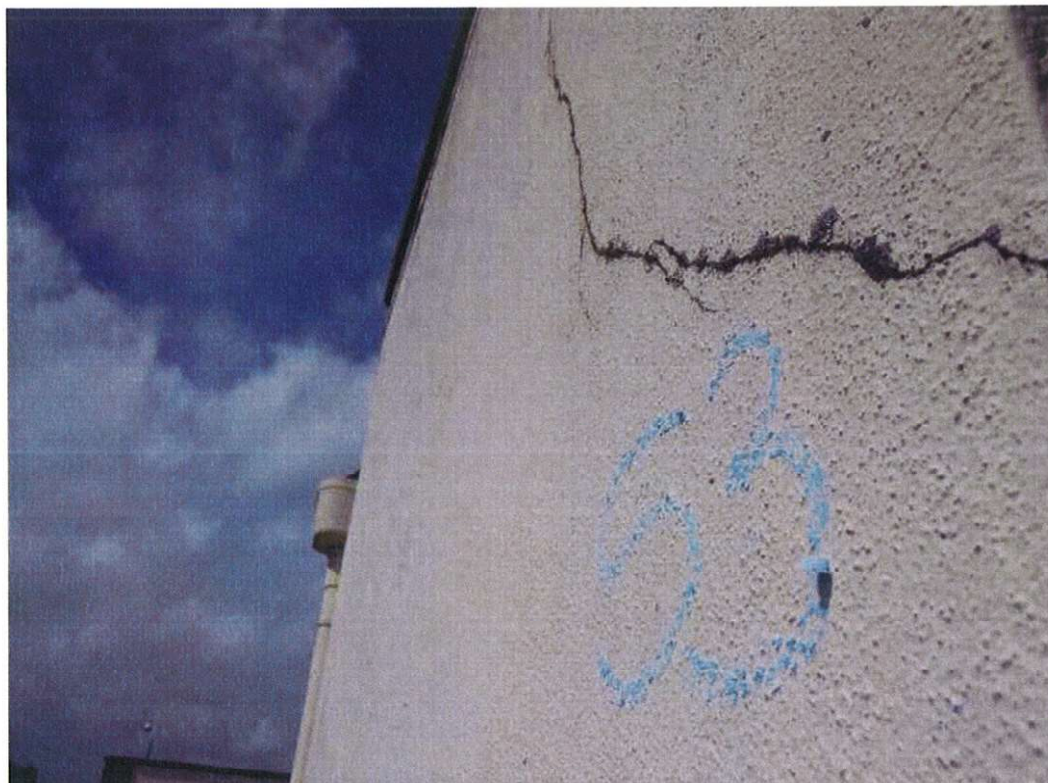
Photo 21: View showing a multi-directional crack measuring 500x1mm to side elevation D (Windermere Way).

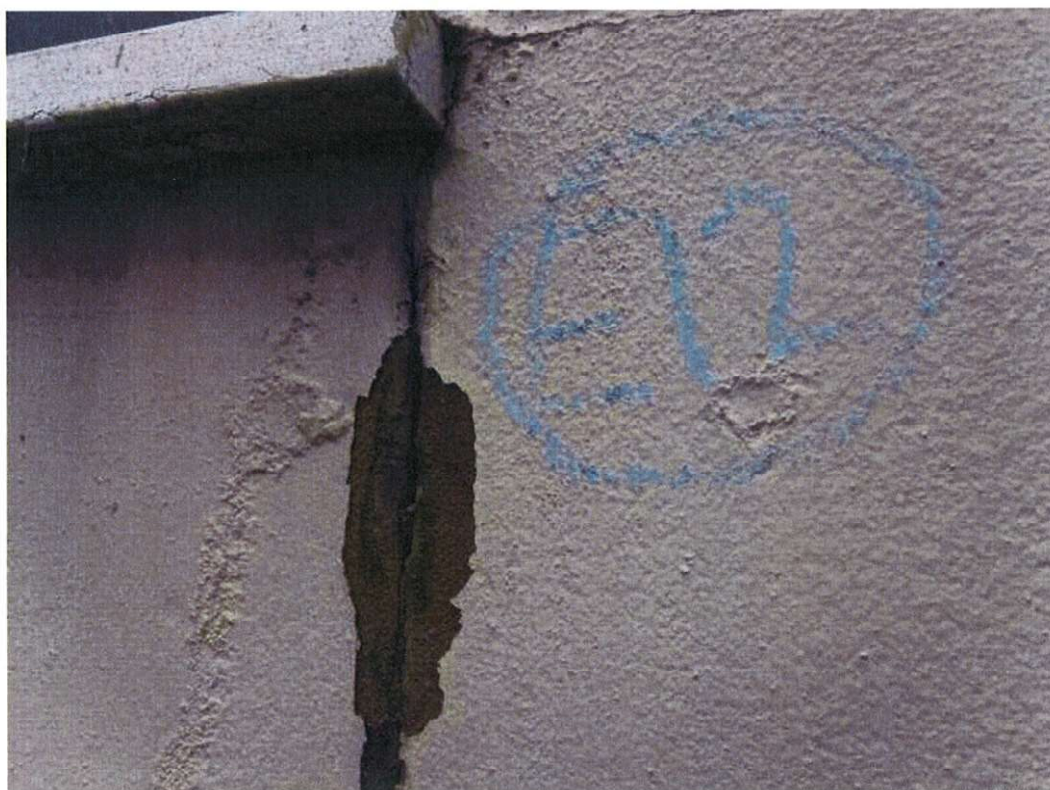
Photo 22: View showing joint mortar loss to the front elevation measuring 100x5x60mm.

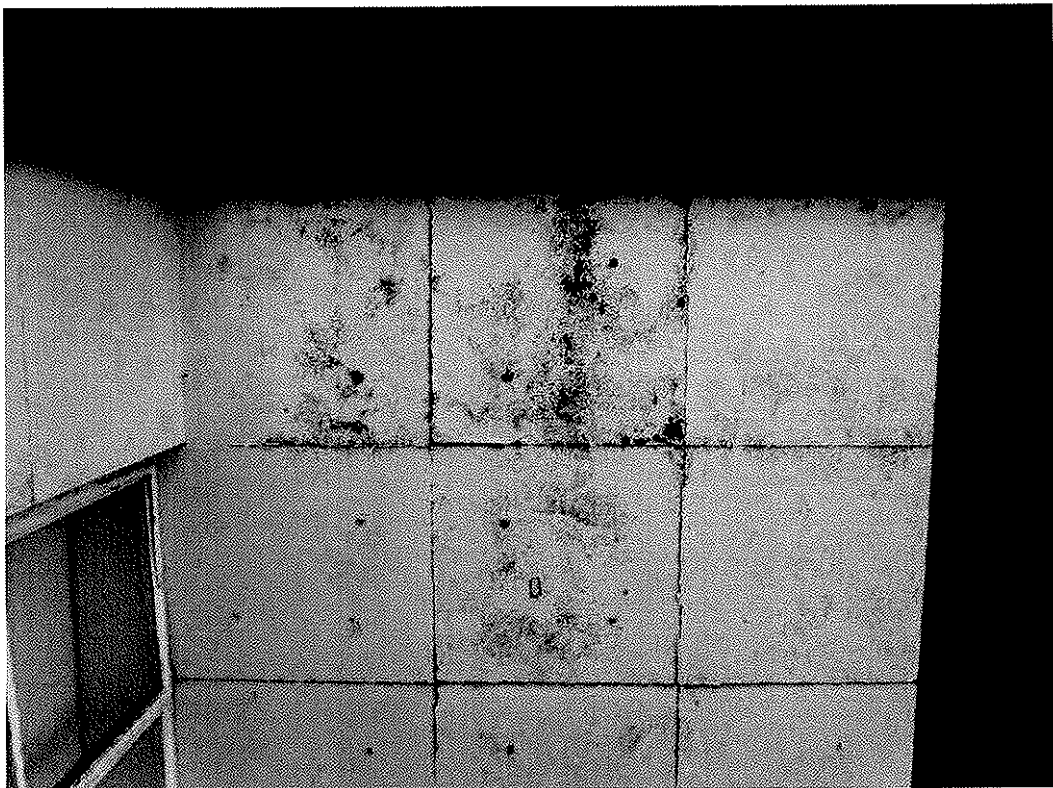
Photo 24: View showing paint flaking to front elevation C.

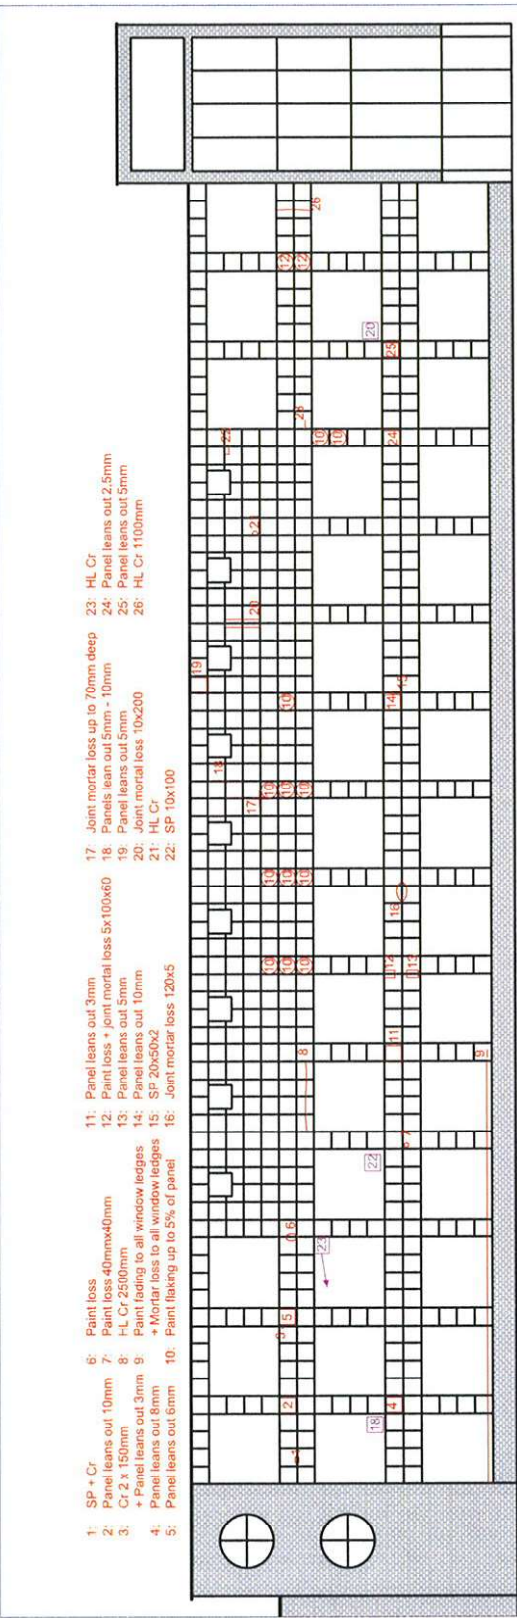
FRONT ELEVATION

Notes:
Paint HL cracking at approx. 80% of panel joints

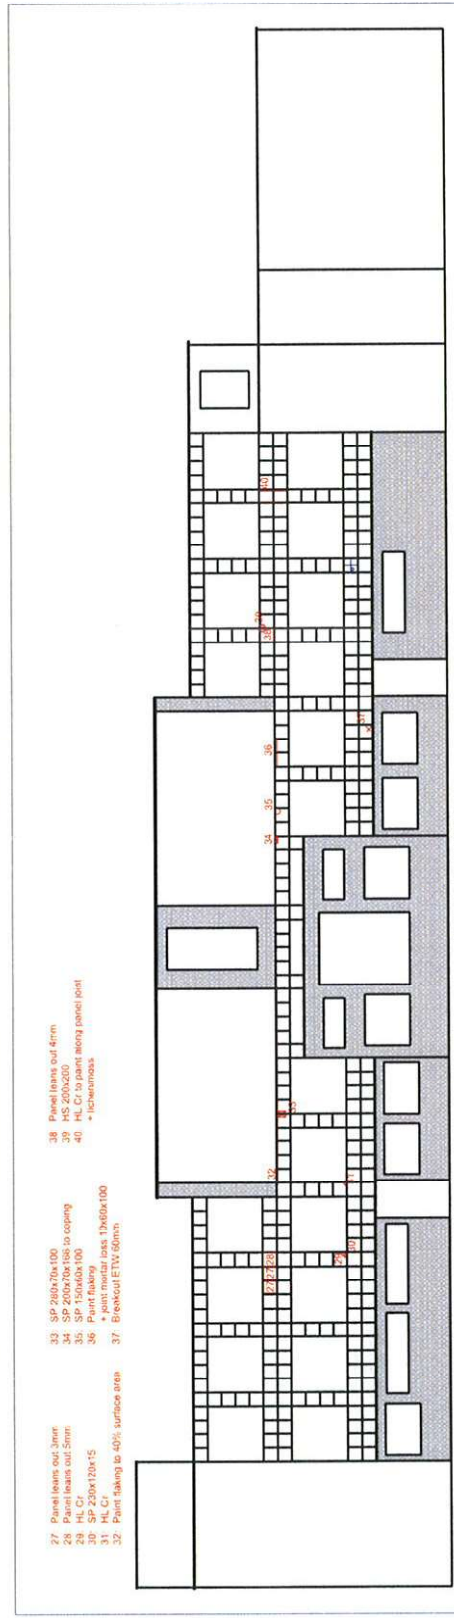
REAR ELEVATION

Notes:
Paint HL cracking at approx. 80% of panel joints

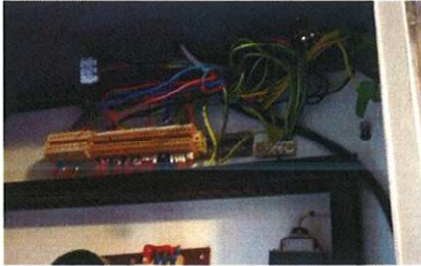
Both blocks have extremely poor and to some extent dysfunctional space heating systems. The Music block has a single heating boiler serving a mix of heat emitters mostly in poor condition. There is no up to date gas safety system. The Drama block features a very dilapidated hot air unit in the roof void. There is no up to date gas safety system in this space either.

Music block heating controls wiring
