Hearing Statement

Matter 6(ii): Other Allocations for Housing and Mixed Uses; Reserved Housing Sites - Stourport on Severn

**CONDITION SURVEY ASSESSMENT INCLUDING ALL
WEATHER PITCH BUDGET FEASIBILITY REVIEW**

STOURPORT HIGH SCHOOL AND SIXTH FORM CENTRE - BUDGET REPAIRS COSTS OCT 2020

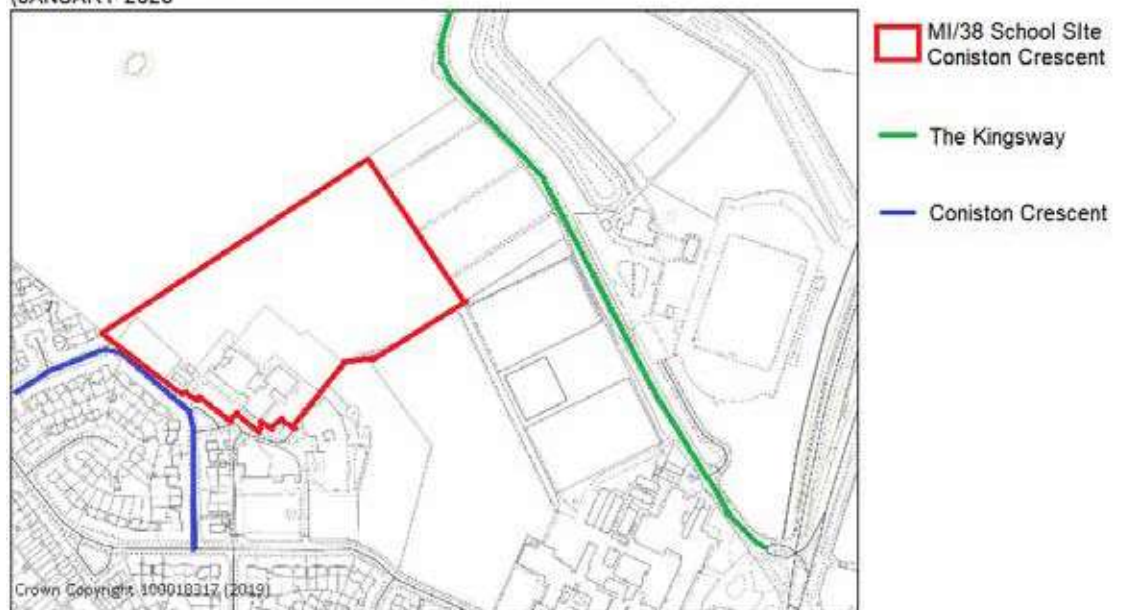
Figure 1 – Proposed Allocation MI/38 with The Kingsway and Coniston Crescent Highlighted

- 1.10 Policy 33.15 'School Site, Coniston Crescent - MI/38', includes three criteria for the development of the site. The first criterion is that vehicular access should be taken from The Kingsway, adjacent to the allotments. Taylor Wimpey object to the wording of this section of the policy.
- 1.11 The extent of the proposed allocation is shown in Appendix B of the emerging Plan. Taylor Wimpey control the full extent of the land included within the allocation. The Plan in Appendix B is reproduced at Figure 1 below; The Kingsway is shown as solid green line; and Coniston Crescent as a blue solid line.

- 1.12 The proposed allocation is separated from The Kingsway by an area of allotments and part of a former golf club that is owned by the Council. Taylor Wimpey are currently in the process of negotiating an agreement with the Council that will allow a road to be constructed from the north western edge of the proposed allocation to The Kingsway. In order to create the access, approximately 100m of new road will need to be constructed between the proposed allocation and The Kingsway. There is currently no footpath along The Kingsway. Taylor Wimpey are advised by their Highways Consultants, DTA that a pavement will need to be constructed along the southern edge of The Kingsway, to the point of access with Stourport High School. It is expected that the junction between The Kingsway and the Minster Road will need to be upgraded. Whilst this is all achievable, it is a significant development cost.

- 1.13 An alternative access could be taken from Coniston Crescent to the south west. Coniston Crescent provided access to the Sixth Form block that was located on the south eastern section of the allocation site before it was demolished. There have, therefore, previously been vehicle movements onto Coniston Crescent from the proposed allocation site. Taking access from Coniston Crescent would be a substantially less expensive way of creating an access into the site.

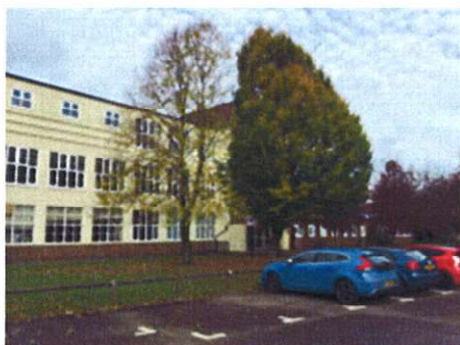
1.37162 The Stourport High School and Sixth Form Centre (CDC) / EFAE / 1

Concrete frame and components - Movement and deterioration to block EFAE cladding panels previously identified in specialist survey by Up and Under Limited. Current panel grouts are failing causing water ingress and accelerated deterioration of the concrete structure. Exposed concrete detailing around window and door openings has spalled and or loose and requires urgent targeted concrete repair.

Roof covering deterioration and life expired felt flat roofs to blocks EFAE, EFAG and EFAH. Associated with the coverings are the parapet walls where water penetration is affecting wall heads. Metal rainwater goods are life expired and currently leaking in many areas to block EFAE.

Leaking rooflights and damaged and leaking main lantern lights. Blocks affected EFAE, EFAG, EFAH and EFAI.

Changing rooms to EFAE are in a poor condition in terms of finishes and services with inoperable showers and recent issues relating to location within the school away from physical activity performed in the school.

Fire alarm panel to block EFAE has been identified as a manual system with inadequate protection identified from the latest fire risk assessment.

Existing curtain walling system to EFAE has insufficient ventilation, multiple units are inoperable and glazing units have failed in multiple locations creating a poor environment for users. It should be noted remaining window units have been replaced across the main school blocks.

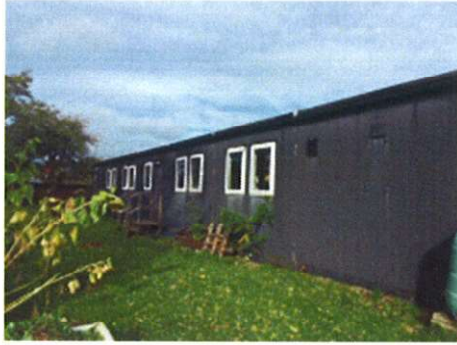
Site	EFA1
Block	EFAF
Building Age	1961-1970
No. of Storeys	1
Basement Area (m2)	0
Gross Internal Floor Area (m2)	186
Ground Floor GIFA (m2)	186
Perimeter (m)	65
Average Height (m)	3
Catering Kitchen	No Kitchen

Block EFAF currently used as a food technology block is beyond economic repair and demolition of the block would be advisable and relocation with the main school block EFAE and remodelling to accommodate this additional accommodation.

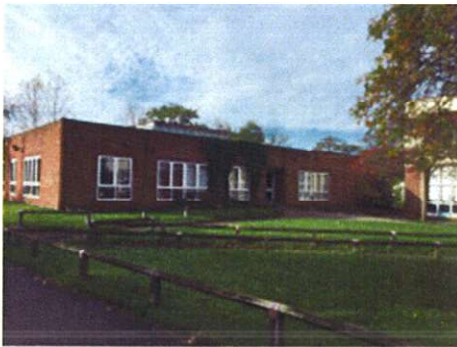
1.37162 The Sloughport High School and South Point Centre (CDC) / EFAG / 1

Heating and mechanical installations within blocks EFAG and EFAH are generally life expired with a warm air heating system. A separate assessment has been carried out by CR Engineering to replace this in the short term.
